Titanium Implant Failure After Chest Wall Osteosynthesis

Philippe Berthet, Abel Gomez Caro, Laurence Solovei, Matthieu Gilbert, Sebastien Bommart, et al..
Titanium Implant Failure After Chest Wall Osteosynthesis. *Annals of Thoracic Surgery*, 2015, 99 (6),
pp.1945 - 1952. 10.1016/j.athoracsur.2015.02.040 . hal-01756816

Background. Our objective was to assess potential contributing factors to implant failure (displacement or rupture) after titanium chest wall osteosynthesis.

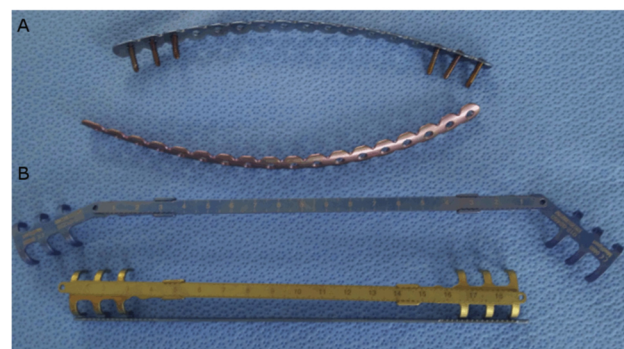
Fig 1. Different types of implants associating a connecting bar or plate and rib fixation system. (A) Plate and screw (Matrix, DePuy Synthes). (B) Bars and clips (Stratos, MedXpert).

The different types of implants and procedures are shown in [Figures 1 and 2](#), respectively.

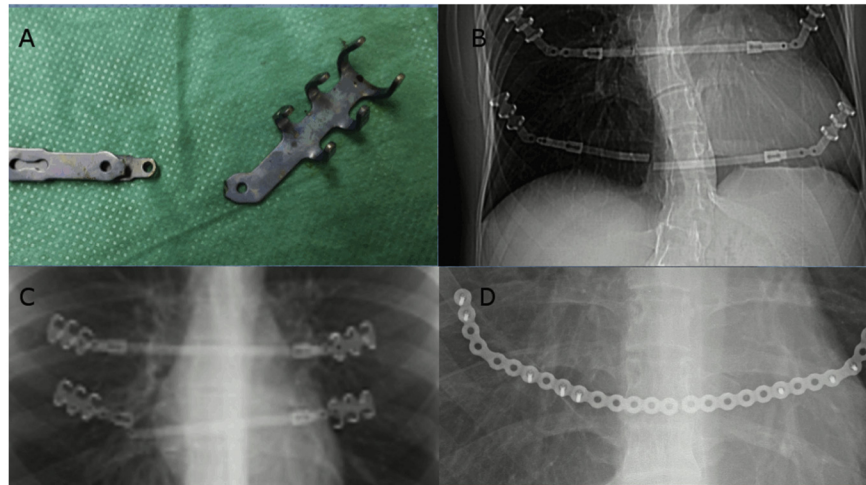
Fig 3. Different types of implant failure. Stratos; MedXpert: (A) Fracture of the rib fixation system at the joint, this part has been reinforced by the manufacturer. (B) Fracture of the connecting bar. (C) Disconnection between bar and clip. Matrix mandible, DePuy Synthes: (D) fracture of the plate.

Implant failure was assessed on chest roentgenogram confirmed by computed tomographic (CT) scan and involved at least one of the following criteria: (1) fracture of the rib fixation system (clip or screw), (2) fracture of the connecting bar or plate, or (3) displacement without fracture of bars, plates, screws, or rib clips, or disconnection between the bar and clip. A distortion of the implant, involving the curvature of the bar or plate, was not identified as an implant failure but was recorded. The different types of implant failure are shown in [Figure 3](#).

The implant was broken in 83.3% of patients and displaced in 16.7%. The rupture of the implant occurred at the level of the clip (n = 7) where it is angled to be adapted to rib shape at the bar (n = 10) or at the plate (n = 2). Implant displacement consisted of loose implants (disjunction between the rib and clip (n = 1) or disjunction between clips and bars (n = 3) (Fig 4). Interestingly, deformations (anteroposterior bending) of the Stratos implants occurred in 22 patients (40.7%) and were associated with rupture in 13 cases. No deformations occurred with the Matrix system.

Aware of the potential risk of life-threatening complications, the manufacturer of the Stratos system has reinforced a point of minor resistance (joint), the designer and some surgical teams have advised that forces and pressures be better distributed by multiplying implants [4, 6, 11] or combining with a mesh [18], and others have proposed that implants be removed 6 to 12 months after repair [10, 19] or that stronger [5, 10], modified [9], or absorbable [20] fixation material be used. In our experience, the combination of TCWO with a synthetic mesh or flap did not lessen the failure rate.

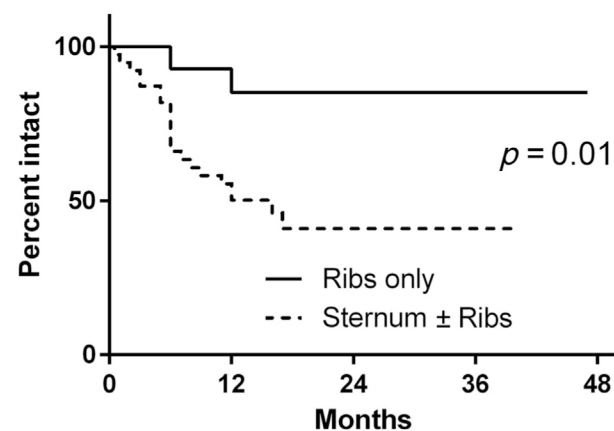
months	1	12	24	36	48
Sternum ± ribs No. at risk	39	22	4	2	1
Ribs only No. at risk	15	14	5	3	1

Fig 5. Survival without implant failure according to the location of chest wall defect and titanium chest wall osteosynthesis.

Factors contributing to implant failure were as follows: among factors potentially contributing to implant failure given in Table 2, two significantly influenced the survival curve without implant failure (Figs 5 and 6): the anterior location of TCWO ($p = 0.01$) and the presence of three or more implants ($p = 0.03$). The initial pathologic condition, type of implants, extent of the defect, and combination of flap or mesh did not influence the risk of implant failure.

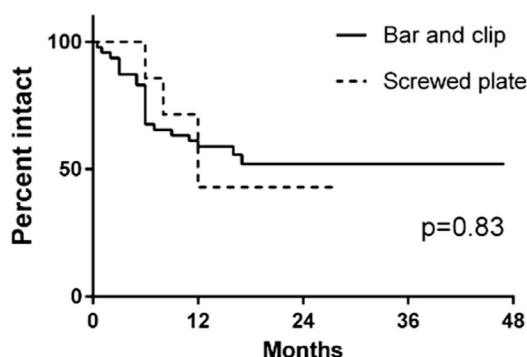
Fig 6. Survival without titanium implant failure according to the combination with (A) a mesh, (B) the indication for reconstruction, (C) the number of implants, and (D) the type of implants.
