# Understanding Aging Mechanisms in the Context of UV Irradiation of a Low Fouling and Self-Cleaning PVDF-PVP-TiO<sub>2</sub> Hollow-Fiber Membrane

**Abstract:** In the context of designing a photocatalytic self-cleaning/low-fouling membrane, the stability of PVDF-PVP-TiO<sub>2</sub> hollow-fiber membranes under UV irradiation has been studied. The effect of irradiation power, aqueous environment composition and fouling state on the properties of the membranes has been investigated. With this aim, SEM observations, chemical analysis and tensile strength measurements have been conducted. The results indicate that pristine membranes that undergo UV irradiation in ultra-pure water are significantly degraded due to attacks of OH<sup>•</sup> radicals. However, when methylene blue, used as a model pollutant, is introduced in the aqueous environment, OH<sup>•</sup> radicals preferentially react with this molecule rather than the membranes, successfully preserving the original properties of the latter. The presence of an adsorbed BSA layer (pre-fouling by immersion) on the surface of the membrane delays membrane aging, as the BSA layer is degraded by radicals instead of the membrane mater

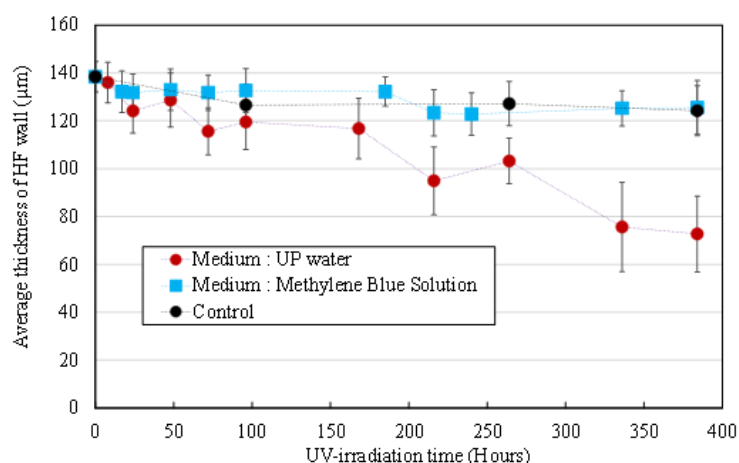
Figure 4 shows the evolution of the average HF’s wall thickness during UV irradiation in an MB solution (blue squares) and UP water (red dots). For the whole duration of the experiment, no significant variation of wall thickness was observed for HF’s irradiated in an MB solution (compared to the control non-UV irradiated HF’s soaking in an MB solution, black dots), when a drastic decrease of wall thickness was observed on HF’s irradiated in UP water. The presence of MB molecules in the aqueous medium successfully inhibits the alteration of the membrane material.

**Figure 4.** Average thickness of HF’s wall after UV irradiation at  $1000 \mu\text{W}/\text{cm}^2$  in an MB solution (blue squares), in UP water (red dots). Control is non-irradiated HF’s in an MB solution (black dots).

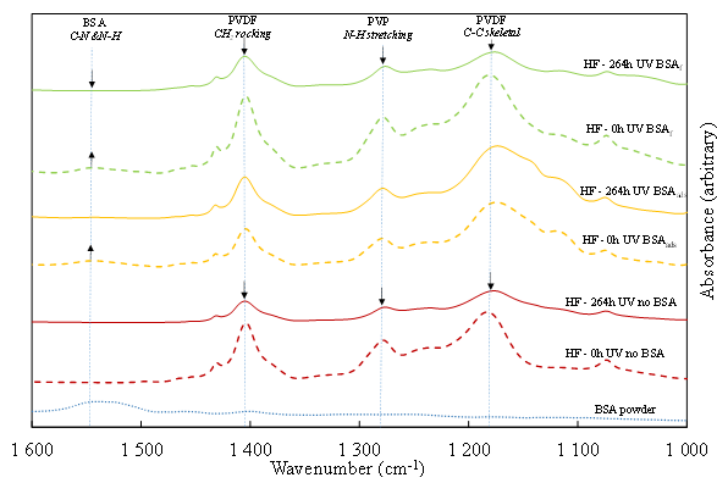
An ATR-FTIR spectrum was first obtained for BSA powder and it displays a large characteristic peak in the range of  $1490\text{--}1570 \text{ cm}^{-1}$  that corresponds to an amine function of the BSA molecule [37] (Figure 10, dotted blue line). This peak is also visible on the spectra of HF's pre-fouled by BSA before irradiation (Figure 10, dashed yellow and green lines). The spectra obtained on HF's display peaks at  $1403$  and  $1180 \text{ cm}^{-1}$  which correspond respectively to the vibration of C–C bonds and CH<sub>2</sub> bonds of PVDF. The peak observed at  $1291 \text{ cm}^{-1}$  corresponds to the stretching of N–H bonds in the PVP molecule [21].

**Figure 10.** ATR-FTIR spectra for BSA powder (dotted blue line), pristine HF (dashed red line), 264 h UV irradiated pristine HF (solid red line), 0 h UV irradiated BSA<sub>ads</sub> HF (yellow dashed line), 264 h UV irradiated BSA<sub>ads</sub> HF (solid yellow line), 0 h UV irradiated BSA<sub>f</sub> HF (green dashed line), 264 h UV irradiated BSA<sub>f</sub> HF (solid green line).

On non-fouled HFs (pristine), peaks associated with PVDF and PVP decrease after 264 h of UV irradiation, which means that polymer bonds are broken by the action of OH° radicals. This is perfectly coherent with observations made in Sections 3.3.1 and 3.3.2, where significant morphological and chemical degradation was noticed, which led to the embrittlement of the HFs and significant losses to their mechanical properties.

Spectra obtained on BSA<sub>ads</sub> HFs before and after UV irradiation display similar PVDF and PVP peak height, meaning that the chemical structure of HFs was preserved from OH° attacks. As the peak associated with BSA disappeared from the BSA<sub>ads</sub> spectra after UV irradiation, we conclude that HFs self-cleaning was successful.

Comparison of spectra obtained on BSA<sub>f</sub> HFs before and after irradiation also show the disappearance of the peak associated with BSA. However, peaks associated with PVDF and PVP show a significant decrease after irradiation. This means that, even if the degradation of the BSA layer could have slightly delayed the action of OH° radicals on polymer bonds, the protective effect of the BSA layer was not enough to preserve the membrane material.
