Article

Understanding Aging Mechanisms in the Context of UV Irradiation of a Low Fouling and Self-Cleaning PVDF-PVP-TiO₂ Hollow-Fiber Membrane

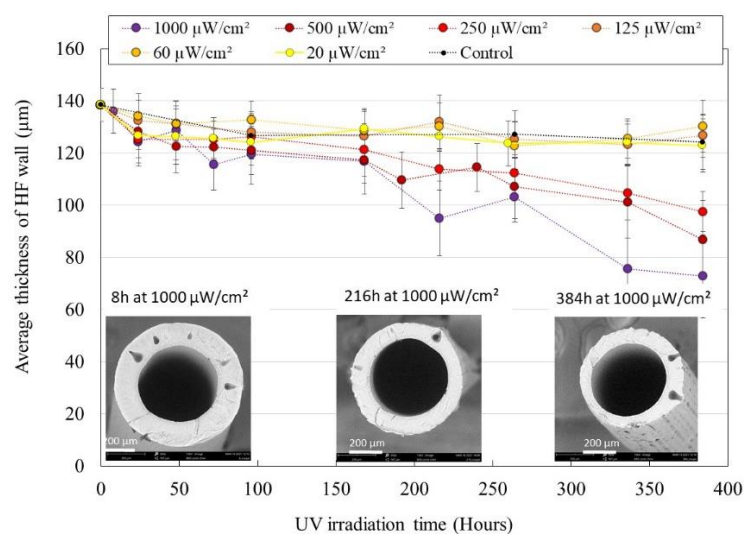
UV irradiated HFs samples were characterized to assess the degradation of their morphological properties. Figure 1 shows the evolution of average HF wall thickness during exposition to UV light at various irradiation powers. At an irradiation power of 250, 500 and 1000 $\mu\text{W}/\text{cm}^2$, a significant decrease in HFs' wall thickness was observed, down to -50% for HFs irradiated at 1000 $\mu\text{W}/\text{cm}^2$ for 384 h. Measurements of HFs' internal diameter showed no evolution during the whole experiment, meaning that the degradation happens on the external side of the HFs. At an irradiation power of 20, 60 and 125 $\mu\text{W}/\text{cm}^2$, no significant evolution of HFs' wall thickness was observed when compared to the evolution of control HFs (membranes soaked in UP water without irradiation).

SEM images of the cut HFs showed the presence of frequent drop-like macrovoids inside the membrane wall (average length 54 ± 16 μm ; average width 29 ± 5 μm). External layer degradation made those macrovoids clearly visible on the HFs outer surface (Figure 1, right SEM image). Cracks appeared running along the lines of emerging macrovoids, which is commonly observed in similar membrane aging studies [22–24].

Figure 1. Average thickness of HF's wall after UV irradiation in UP water with various irradiation powers. Insert: SEM images of HF's irradiated at $1000 \mu\text{W}/\text{cm}^2$ during 8 h, 216 h or 384 h ($\times 350$ magnification).

the highest three irradiation powers. These “groups” suggest that at an irradiation power of $250 \mu\text{W}/\text{cm}^2$ or more, HF’s mechanical, chemical and morphological degradation gets faster. Figure 1 shows that a significant decrease in HF wall thickness is only observed for HF’s irradiated at $250 \mu\text{W}/\text{cm}^2$ or more. The emergence of TiO_2 NP originally entrapped inside HF’s skin and their exposition to UV light as the membrane material gets degraded could further enhance degradation speed.

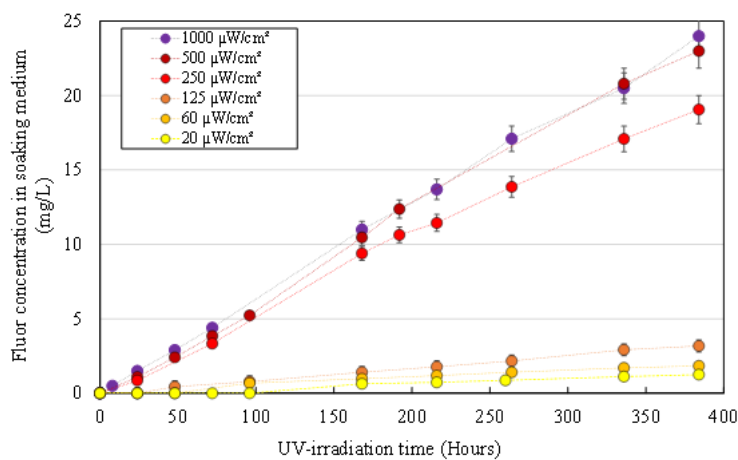
PVDF degradation was confirmed through the analysis of fluorine concentration in the soaking medium of UV irradiated HF's. The fluorine concentration in the bath during UV exposition is presented in Figure 2. Significant increases of fluorine concentration were observed even at the lowest irradiation power. In liquid samples collected in the control beaker, fluorine was not detected through ionic chromatography analysis.

Figure 2. Fluorine concentration in UV irradiated HF's soaking medium for different irradiation powers.

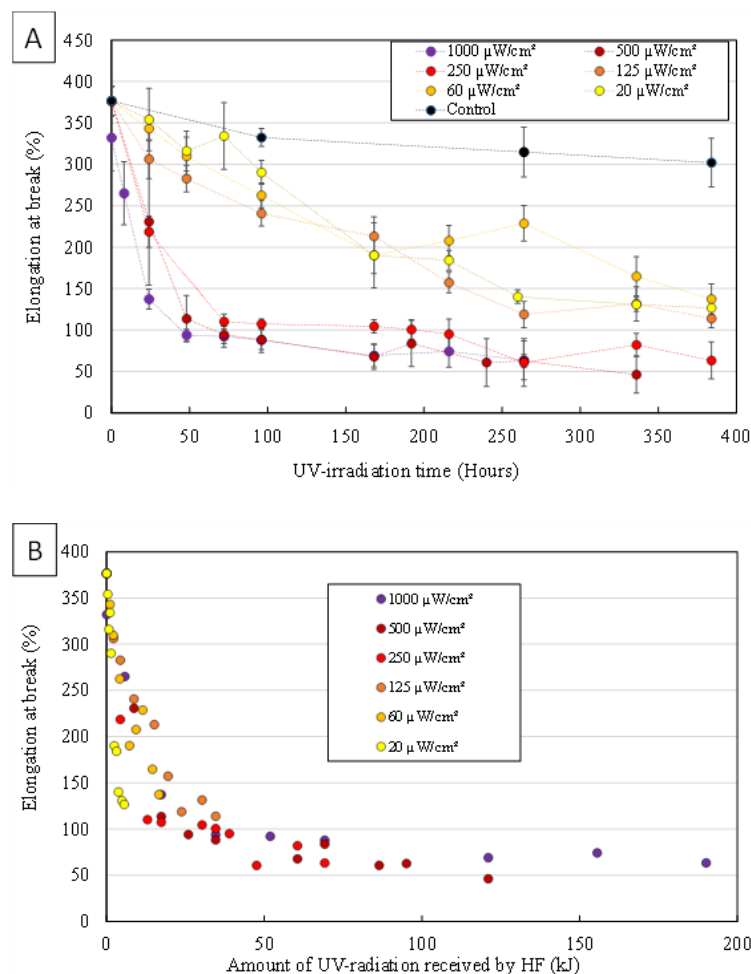
Tensile strength tests were performed on UV irradiated HF samples to assess the degradation of their mechanical properties. Figure 3A shows the effects of UV irradiation power and duration on elongation at break of HF.

Figure 3. Elongation at break measured on UV irradiated HF samples as a function of (A) the irradiation time or (B) the amount of UV radiation received.

Elongation at break decreased significantly from the first hours of irradiation even at the lowest irradiation power (20 $\mu\text{W}/\text{cm}^2$). At the highest irradiation power (1000 $\mu\text{W}/\text{cm}^2$), after 336 h of UV exposure, HF samples had become so brittle that it was not possible to correctly perform the tensile strength measurements. As resistance is closely related to membrane structure, elongation at break is a direct measure of membrane damage [17]. The reduced HF wall thickness due to intense PVDF degradation, the macroporous structure caused by the emerging macrovoids and the possible embrittlement of the remaining polymer material resulted in deleterious effects on the mechanical strength of HF [17,22,23,28,30]. This caused most HF samples to lose their integrity and for this reason, aged HF samples could not be properly characterized in terms of water permeability during the experiments.

Figure 3B shows the effects of the amount of UV radiation received by HF’s on elongation at break. As all data points follow the same envelope, we assume that the degradation mechanisms are the same regardless of the UV irradiation power used. The observed phenomenon only depends on the amount of UV radiation received by the fibers.

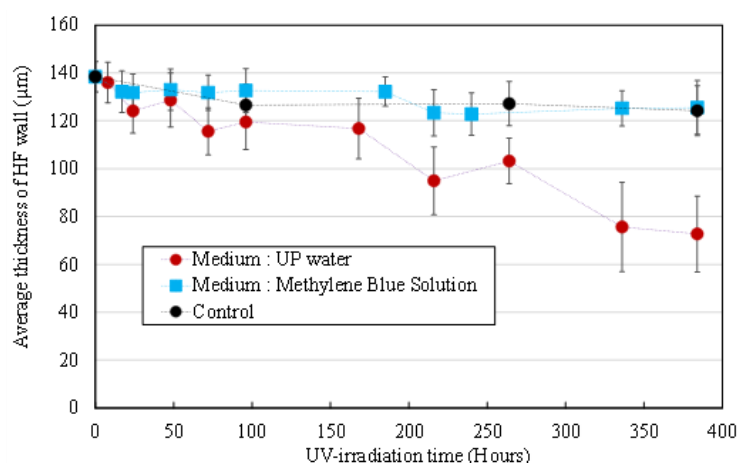
Figure 4 shows the evolution of the average HF’s wall thickness during UV irradiation in an MB solution (blue squares) and UP water (red dots). For the whole duration of the experiment, no significant variation of wall thickness was observed for HF’s irradiated in an MB solution (compared to the control non-UV irradiated HF’s soaking in an MB solution, black dots), when a drastic decrease of wall thickness was observed on HF’s irradiated in UP water. The presence of MB molecules in the aqueous medium successfully inhibits the alteration of the membrane material.

Figure 4. Average thickness of HF’s wall after UV irradiation at $1000 \mu\text{W}/\text{cm}^2$ in an MB solution (blue squares), in UP water (red dots). Control is non-irradiated HF’s in an MB solution (black dots).

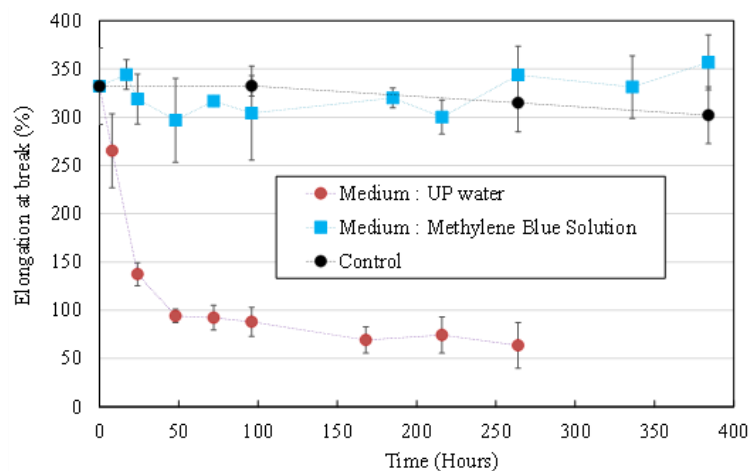
Figure 5 shows the evolution of the average HF’s elongation at break during UV irradiation in an MB solution (blue squares) and UP water (red dots). As for average wall thickness, no significant variation of elongation at break was observed for HF’s irradiated in an MB solution (compared to the control non-UV irradiated HF’s soaking in an MB solution,

Figure 5. Elongation at break measured on HF irradiated at $1000 \mu\text{W}/\text{cm}^2$ in an MB solution (blue squares), in UP water (red dots). Control is non-irradiated HF in an MB solution (black dots).

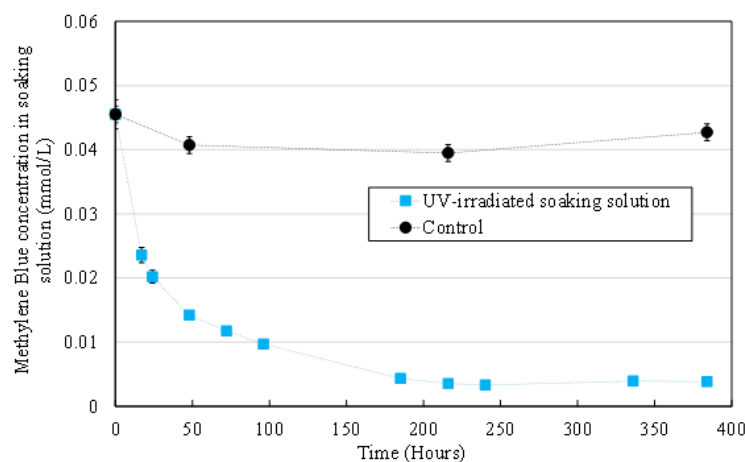
MB concentration was measured by absorbance spectroscopy at 670 nm for liquid samples collected from the soaking medium of irradiated HF (blue squares) and non-irradiated control HF (black dots). Results are displayed in Figure 6.

Figure 6. MB concentration in liquid samples collected from the soaking medium of irradiated HF (blue squares) and non-irradiated control HF (black dots).

An important decrease was observed for MB concentration in the soaking medium of UV irradiated HF. This decrease cannot be attributed to direct MB photolysis under UV irradiation as it has been shown by Zhang et al., [31] for a similar wavelength and higher light irradiance ($5.3 \text{ mW}/\text{cm}^2$ at $\lambda = 360 \text{ nm}$) that MB was not degraded over 120 min. Moreover, no significant evolution was observed for MB concentration of the control experiment (non-irradiated control HF). These results, associated with the fact that no significant evolution of the morphological and mechanical properties of HF was observed (Figures 4 and 5), imply that OH° radicals preferentially react with MB molecules rather than HF organic components (PVDF and PVP).

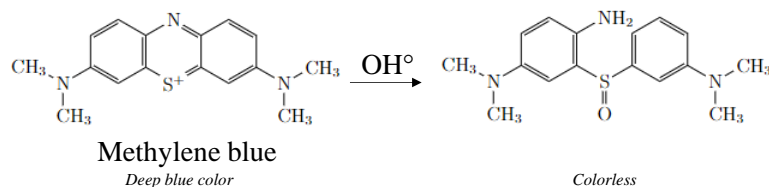
MB degradation through photocatalysis has been thoroughly described in other works [32–34], but those studies fail to mention that the first step of MB oxidation by OH° radicals (cleavage of the central aromatic ring) leads to the discoloration of the molecule (Figure 7) [35]. Therefore, the MB concentration measured with absorbance spectroscopy at 670 nm does not take into account the presence of degradation products in solution after the first oxidation. These biproducts keep on reacting with OH° radicals until total mineralization [32]. The experiment could not be carried out long enough to see HF degradation after all organic molecules had been mineralized. Since the experiment was conducted in static conditions and hydroxyl radicals have an estimated half-life of about 10^{-9} s [36], it is likely that they do not diffuse in the aqueous medium to oxidize MB in the bulk solution. Instead, the reaction must happen near the TiO_2 NP entrapped in the HFs, where radicals are produced thanks to UV irradiation. MB concentration near the HFs is locally decreased but quickly balanced through the diffusion of MB from the bulk.

Figure 7. Opening of the central aromatic ring of an MB molecule after electrophilic attack of OH° on the free doublet of heteroatom S.

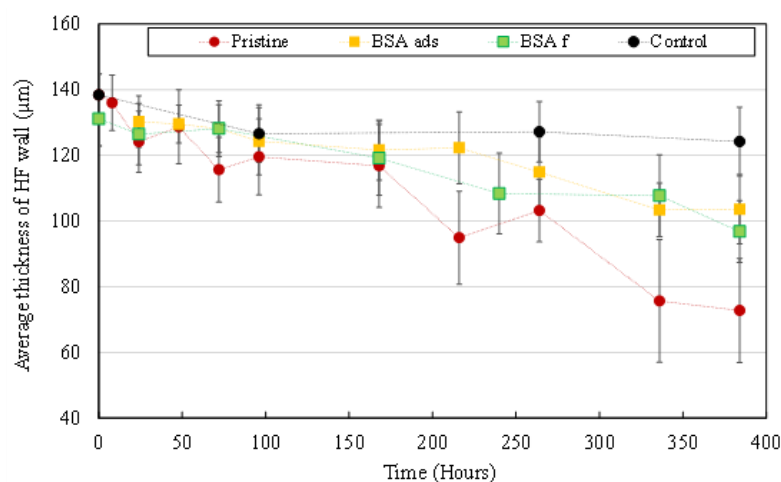
Figure 8 shows the evolution of the average wall thickness of sampled HFs. The presence of a BSA layer on HFs' surface significantly delays material degradation during UV irradiation. After 384 h of irradiation, the average thickness had decreased by 45% for pristine HFs but only by 29% and 25% for BSA_f and BSA_{ads} HFs, respectively. However, there is no significant difference to the average wall thickness between BSA_f and BSA_{ads} HFs.

Figure 8. Average thickness of HF's wall after UV irradiation at $1000 \mu\text{W}/\text{cm}^2$. Pristine HF's (red dots), BSA pre-adsorbed HF's (yellow squares) and BSA pre-filtrated HF's (green squares). Control (black dots) = pristine HF's without UV irradiation.

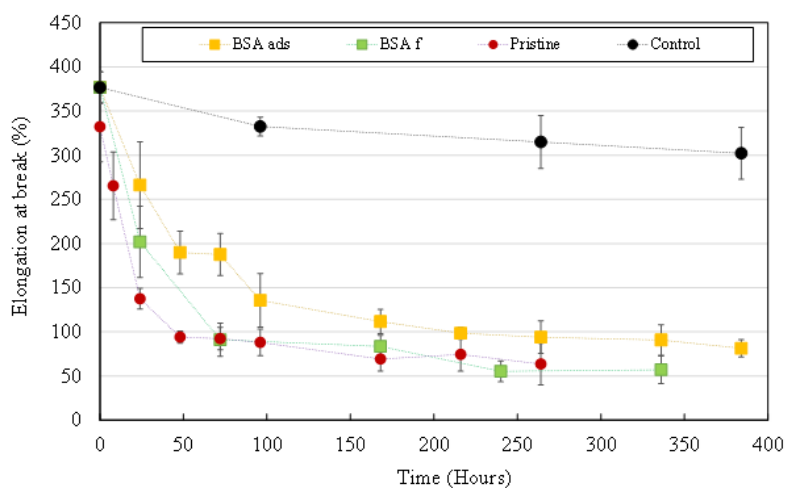
Figure 9 shows the evolution of the elongation at break values of sampled HFs. During the first hours of UV irradiation, the presence of a BSA layer slightly delays degradation of the mechanical properties of HFs. After 24 h of irradiation, elongation at break had decreased by 64% for pristine HFs but only by 47% and 30% for BSA_f and BSA_{ads} , respectively. For BSA_f HFs, elongation at break results ended up being similar to what was obtained on pristine HFs after 72 h of irradiation. Mechanical properties of BSA_{ads} HFs were slightly

Figure 9. Elongation at break measured on UV irradiated HF's ($1000 \mu\text{W}/\text{cm}^2$). Pristine HF's (red dots), BSA_{ads} HF's (yellow squares) and BSA_f HF's (green squares). Control (black dots) = pristine HF's without UV irradiation.

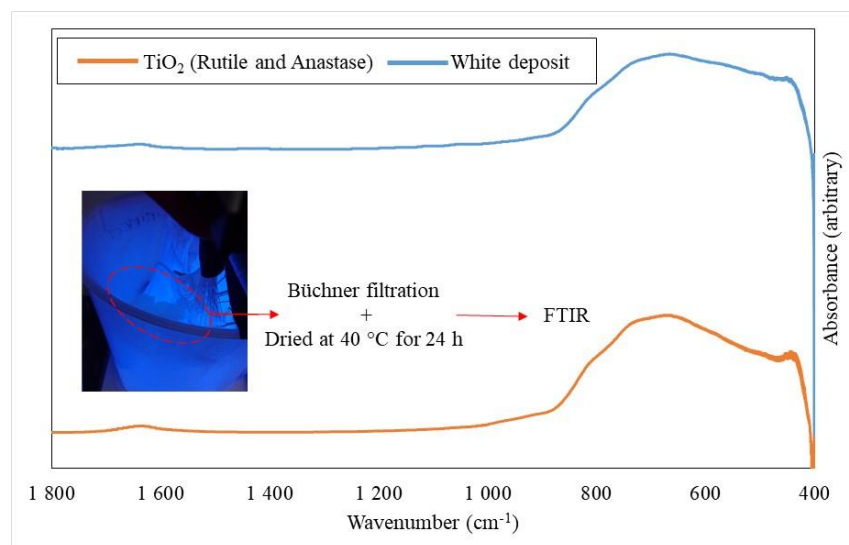
Figure A1. FTIR spectra of commercial TiO₂ used in the production of the membrane (orange) and of the dried white deposit observed in the soaking medium (blue).

beaker (nature of the deposit was confirmed through ATR-FTIR analysis, see Appendix A). Titanium concentration in solution qualitatively increased during irradiation. As TiO₂ NP tends to form clots, sampling could not be performed homogeneously and the graphical representation of titanium concentration during irradiation is not displayed here.
