Understanding Aging Mechanisms in the Context of UV Irradiation of a Low Fouling and Self-Cleaning PVDF-PVP-TiO₂ Hollow-Fiber Membrane

Article

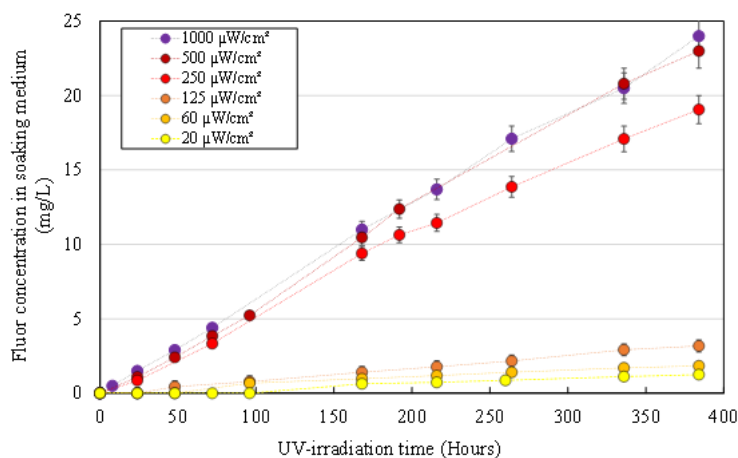
Figure 2. Fluorine concentration in UV irradiated HF's soaking medium for different irradiation powers.

PVDF degradation was confirmed through the analysis of fluorine concentration in the soaking medium of UV irradiated HF's. The fluorine concentration in the bath during UV exposition is presented in Figure 2. Significant increases of fluorine concentration were observed even at the lowest irradiation power. In liquid samples collected in the control beaker, fluorine was not detected through ionic chromatography analysis.

The dehydrofluorination phenomenon, which is an ionic mechanism, is commonly observed on PVDF membranes exposed to UV light and consists in the formation of a carbon-carbon double bond as a result of the elimination of hydrogen fluoride from the polymer [25,26]. This reaction causes PVDF to change color from white to brown [23], which was not observed in our HF's. Instead, the PVDF forming the structure of HF's was degraded, which is supported by the SEM images and measurements presented in Figure 1. This degradation doubtless happens through radical processes which include polymer chain scission, double bond formation, crosslinking and secondary oxidative reactions [27–29]. As PVP is known to be highly sensitive to radical oxidation, we can speculate that oxidation of the PVP component promoted the oxidation of the PVDF component, as it was the case for Prulho et al., with a polyethersulfone/PVP ultrafiltration membrane in contact with bleach water [18]. The complete degradation of the membrane structure material led to the release of entrapped TiO_2 NP, which was deposited at the bottom of the soaking

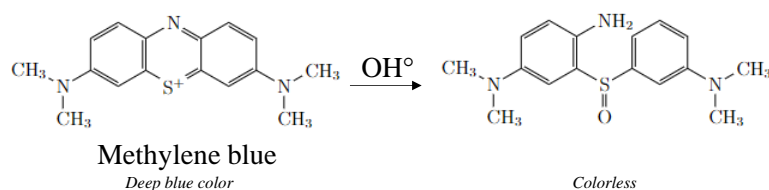
Figure 7. Opening of the central aromatic ring of an MB molecule after electrophilic attack of OH° on the free doublet of heteroatom S.

MB degradation through photocatalysis has been thoroughly described in other works [32–34], but those studies fail to mention that the first step of MB oxidation by OH° radicals (cleavage of the central aromatic ring) leads to the discoloration of the molecule (Figure 7) [35]. Therefore, the MB concentration measured with absorbance spectroscopy at 670 nm does not take into account the presence of degradation products in solution after the first oxidation. These biproducts keep on reacting with OH° radicals until total mineralization [32]. The experiment could not be carried out long enough to see HF degradation after all organic molecules had been mineralized. Since the experiment was conducted in static conditions and hydroxyl radicals have an estimated half-life of about 10^{-9} s [36], it is likely that they do not diffuse in the aqueous medium to oxidize MB in the bulk solution. Instead, the reaction must happen near the TiO_2 NP entrapped in the HFs, where radicals are produced thanks to UV irradiation. MB concentration near the HFs is locally decreased but quickly balanced through the diffusion of MB from the bulk.

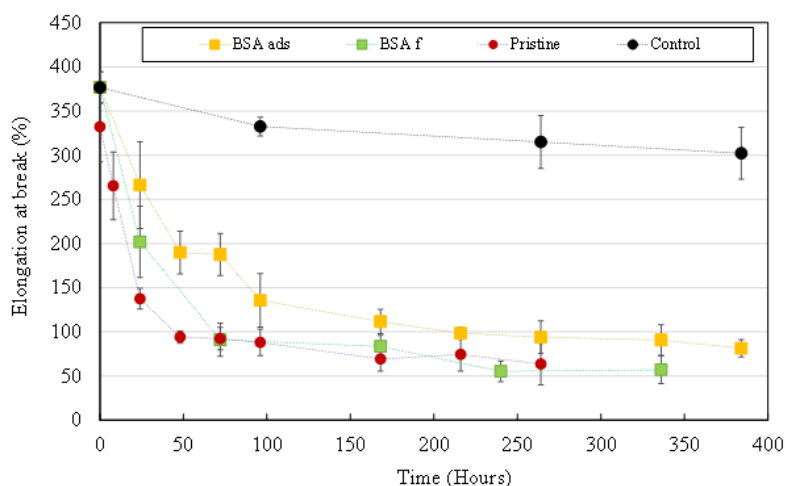
Figure 9. Elongation at break measured on UV irradiated HF_s (1000 $\mu\text{W}/\text{cm}^2$). Pristine HF_s (red dots), BSA_{ads} HF_s (yellow squares) and BSA_f HF_s (green squares). Control (black dots) = pristine HF_s without UV irradiation.

Figure 9 shows the evolution of the elongation at break values of sampled HFs. During the first hours of UV irradiation, the presence of a BSA layer slightly delays degradation of the mechanical properties of HFs. After 24 h of irradiation, elongation at break had decreased by 64% for pristine HFs but only by 47% and 30% for BSA_f and BSA_{ads} , respectively. For BSA_f HFs, elongation at break results ended up being similar to what was obtained on pristine HFs after 72 h of irradiation. Mechanical properties of BSA_{ads} HFs were slightly

more preserved than those of BSA_f HF_s as the elongation at break values stabilized at around 90% and 55%, respectively during the last 7 days (168 h) of the experiment.

Elongation at break results highlighted the fact that both methods of HF_s pre-fouling led to a different extent of protection of the membrane. To further investigate this phenomenon, chemical analysis of HF_s surface was performed through ATR-FTIR spectroscopy.

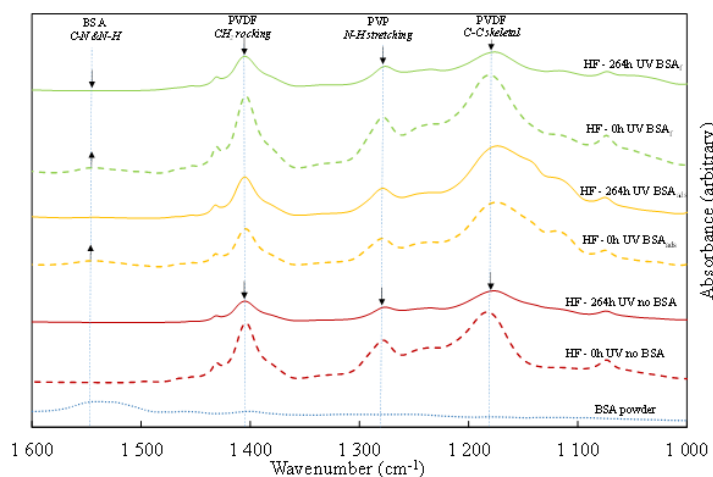
Figure 10. ATR-FTIR spectra for BSA powder (dotted blue line), pristine HF (dashed red line), 264 h UV irradiated pristine HF (solid red line), 0 h UV irradiated BSA_{ads} HF (yellow dashed line), 264 h UV irradiated BSA_{ads} HF (solid yellow line), 0 h UV irradiated BSA_f HF (green dashed line), 264 h UV irradiated BSA_f HF (solid green line).

An ATR-FTIR spectrum was first obtained for BSA powder and it displays a large characteristic peak in the range of 1490–1570 cm^{-1} that corresponds to an amine function of the BSA molecule [37] (Figure 10, dotted blue line). This peak is also visible on the spectra of HF_s pre-fouled by BSA before irradiation (Figure 10, dashed yellow and green lines). The spectra obtained on HF_s display peaks at 1403 and 1180 cm^{-1} which correspond respectively to the vibration of C–C bonds and CH₂ bonds of PVDF. The peak observed at 1291 cm^{-1} corresponds to the stretching of N–H bonds in the PVP molecule [21].

On non-fouled HFs (pristine), peaks associated with PVDF and PVP decrease after 264 h of UV irradiation, which means that polymer bonds are broken by the action of OH° radicals. This is perfectly coherent with observations made in Sections 3.3.1 and 3.3.2, where significant morphological and chemical degradation was noticed, which led to the embrittlement of the HFs and significant losses to their mechanical properties.

Spectra obtained on BSA_{ads} HFs before and after UV irradiation display similar PVDF and PVP peak height, meaning that the chemical structure of HFs was preserved from OH° attacks. As the peak associated with BSA disappeared from the BSA_{ads} spectra after UV irradiation, we conclude that HFs self-cleaning was successful.

Comparison of spectra obtained on BSA_f HFs before and after irradiation also show the disappearance of the peak associated with BSA. However, peaks associated with PVDF and PVP show a significant decrease after irradiation. This means that, even if the degradation of the BSA layer could have slightly delayed the action of OH° radicals on polymer bonds, the protective effect of the BSA layer was not enough to preserve the membrane material.
