Understanding Aging Mechanisms in the Context of UV Irradiation of a Low Fouling and Self-Cleaning PVDF-PVP-TiO₂ Hollow-Fiber Membrane

Article

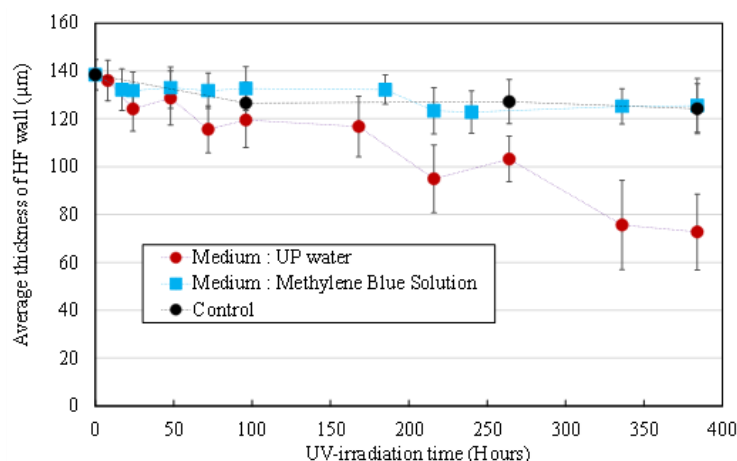
Figure 4 shows the evolution of the average HF’s wall thickness during UV irradiation in an MB solution (blue squares) and UP water (red dots). For the whole duration of the experiment, no significant variation of wall thickness was observed for HF’s irradiated in an MB solution (compared to the control non-UV irradiated HF’s soaking in an MB solution, black dots), when a drastic decrease of wall thickness was observed on HF’s irradiated in UP water. The presence of MB molecules in the aqueous medium successfully inhibits the alteration of the membrane material.

Figure 4. Average thickness of HF’s wall after UV irradiation at $1000 \mu\text{W}/\text{cm}^2$ in an MB solution (blue squares), in UP water (red dots). Control is non-irradiated HF’s in an MB solution (black dots).

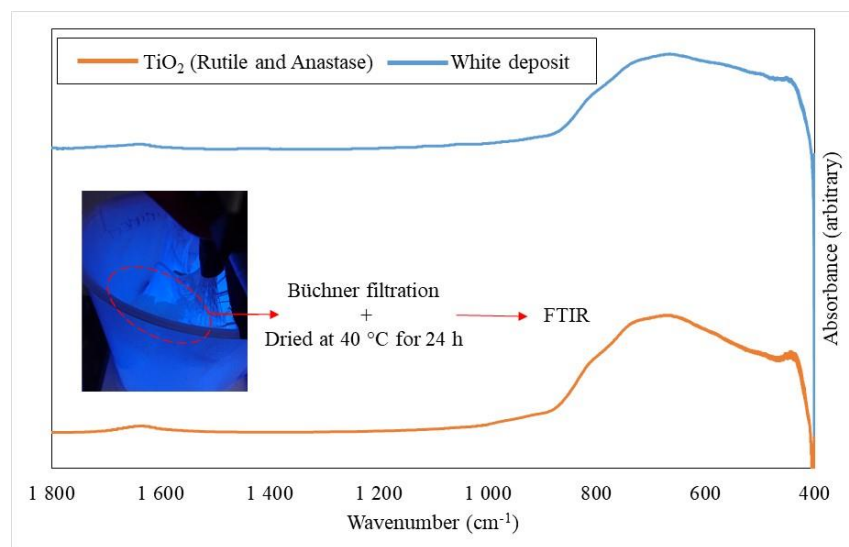
Figure A1. FTIR spectra of commercial TiO₂ used in the production of the membrane (orange) and of the dried white deposit observed in the soaking medium (blue).

beaker (nature of the deposit was confirmed through ATR-FTIR analysis, see Appendix A). Titanium concentration in solution qualitatively increased during irradiation. As TiO₂ NP tends to form clots, sampling could not be performed homogeneously and the graphical representation of titanium concentration during irradiation is not displayed here.
